Report of the Pyrite Panel

June 2012

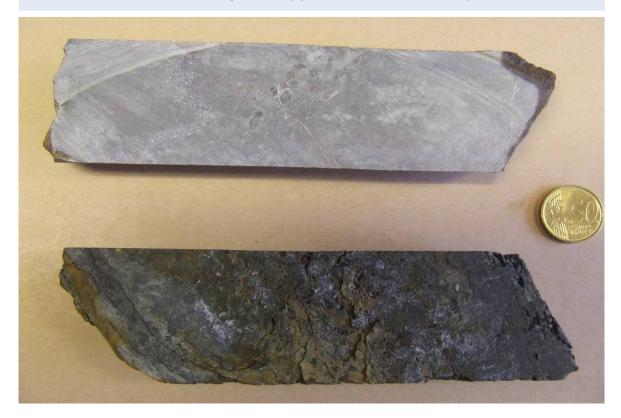
Photograph 2.2 shows two samples of a drill core. The upper drill core is solid limestone without any pyrite which was drilled several years ago and it is still intact. The lower sample contains pyrite and when drilled came out of the ground as a solid cylinder of rock as in the upper sample. However, as is evident, the sample has deteriorated and contains many cracks and loss of integrity. This sample was photographed only one month after it was drilled.

Photograph 2.2 Samples of limestone cores ⁹ Top: Limestone core containing no pyrite (after several years of exposure) Bottom: Limestone core containing reactive pyrite (after one month of exposure)

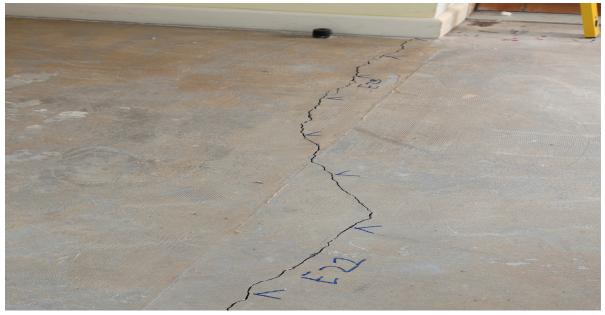
(i) Cracking of floor slab

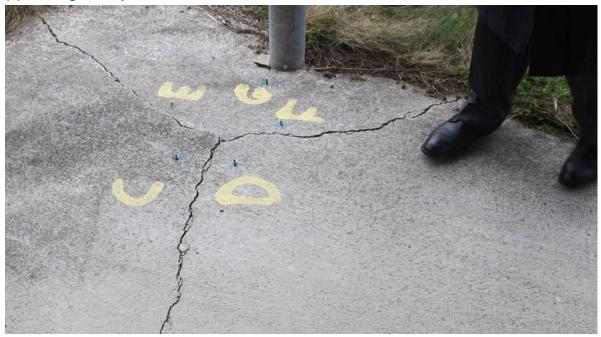
(ii) Cracking of footpath

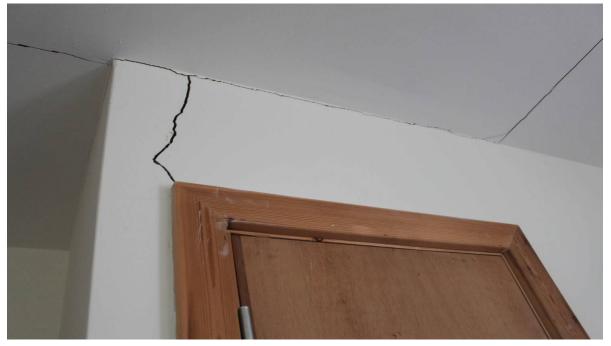
(iii) Cracking at door frames

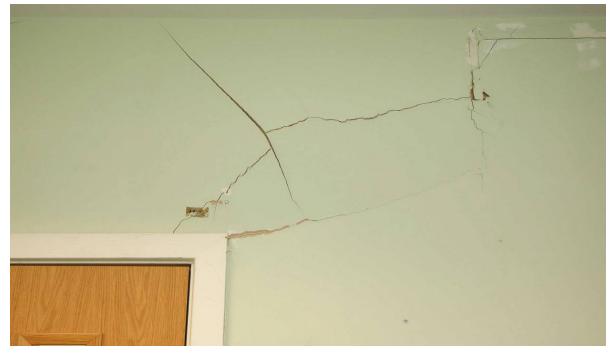
(iv) Cracking at head of door

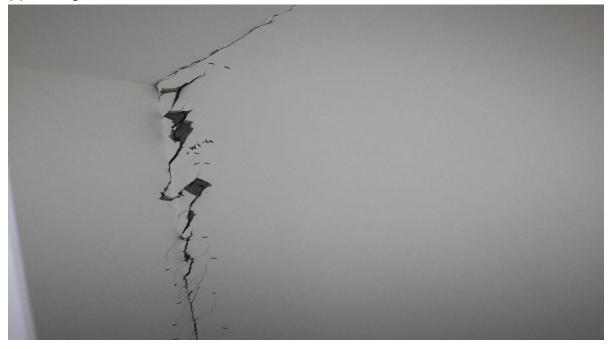
(v) Cracking at corners

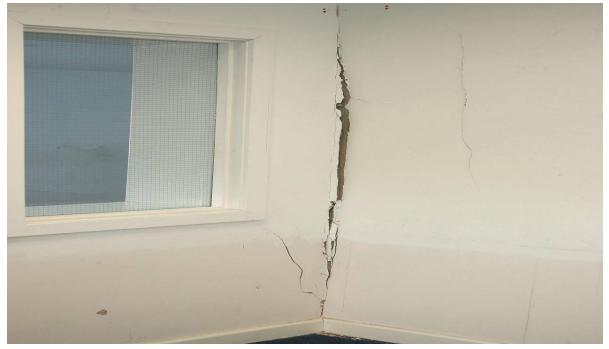
(vi) Bulging of wall finishes

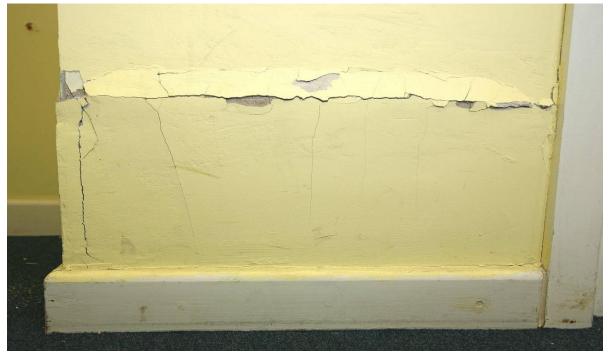
(vii) Bulging of wall finishes

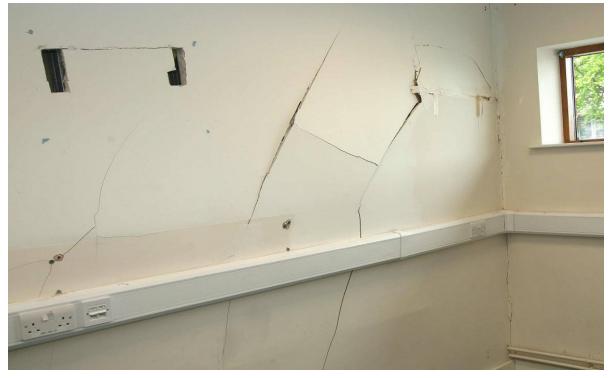
(viii) Bulging of wall finishes

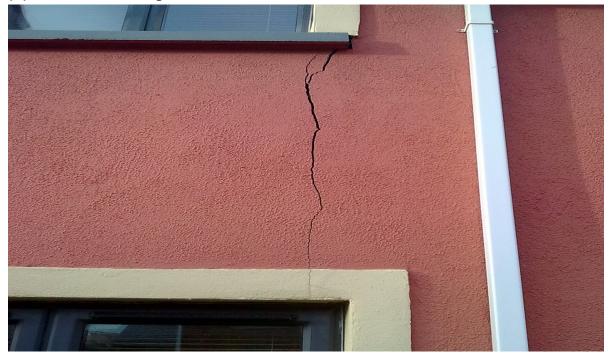
(ix) External wall cracking

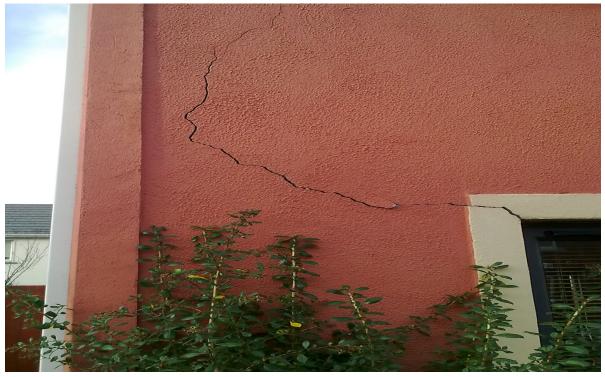
(x) External wall cracking
