Caomhnú Árann EIP Project:

LLOC5013: REHABILITATION OF COASTAL HABITATS THROUGH GRAZING MANAGEMENT

Final Report

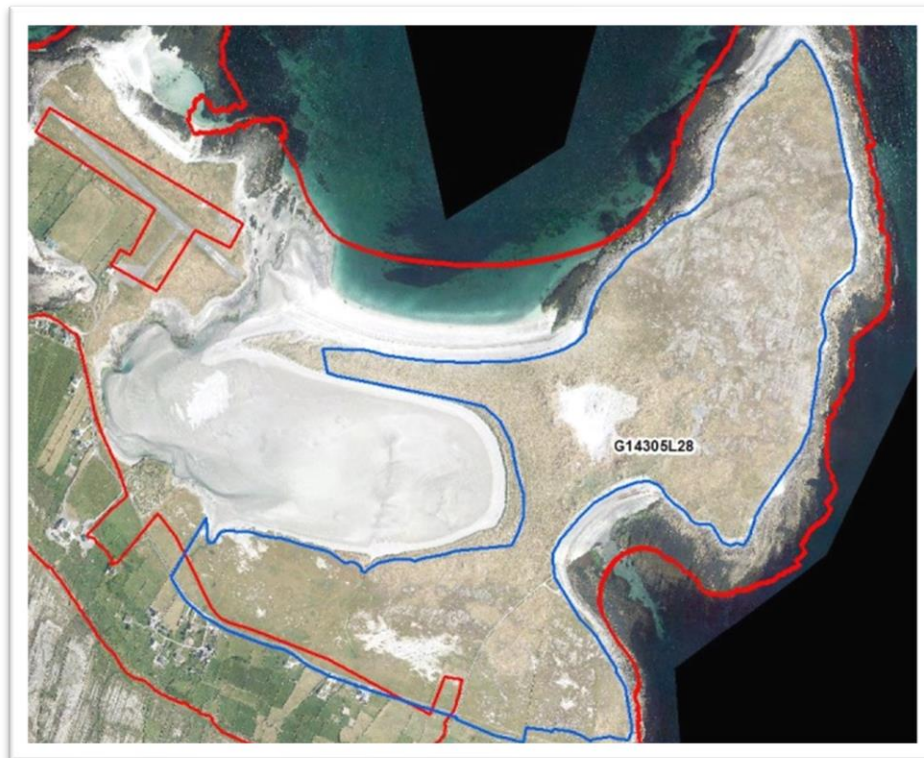
Fig.1 The area of the proposed site outlined in Blue with the SAC designation in red.

Trá Mór Machair site is located in the eastern shores of Inis Mór, Aran Islands, Co. Galway (Grid reference L 90575 07149) (Fig. 1). The site is approximately 79 hectares and is owned by 11 different shareholders all living on the island. The site is designated as a Special Area of Conservation (Inishmore SAC 000213) and part of the site is designated as a Special Protection Area (SPA Inishmore SPA 004152). The area has a Land Parcel number G14305L28. The Machair grasslands are predominantly in the southern part of the parcel (Fig.1).

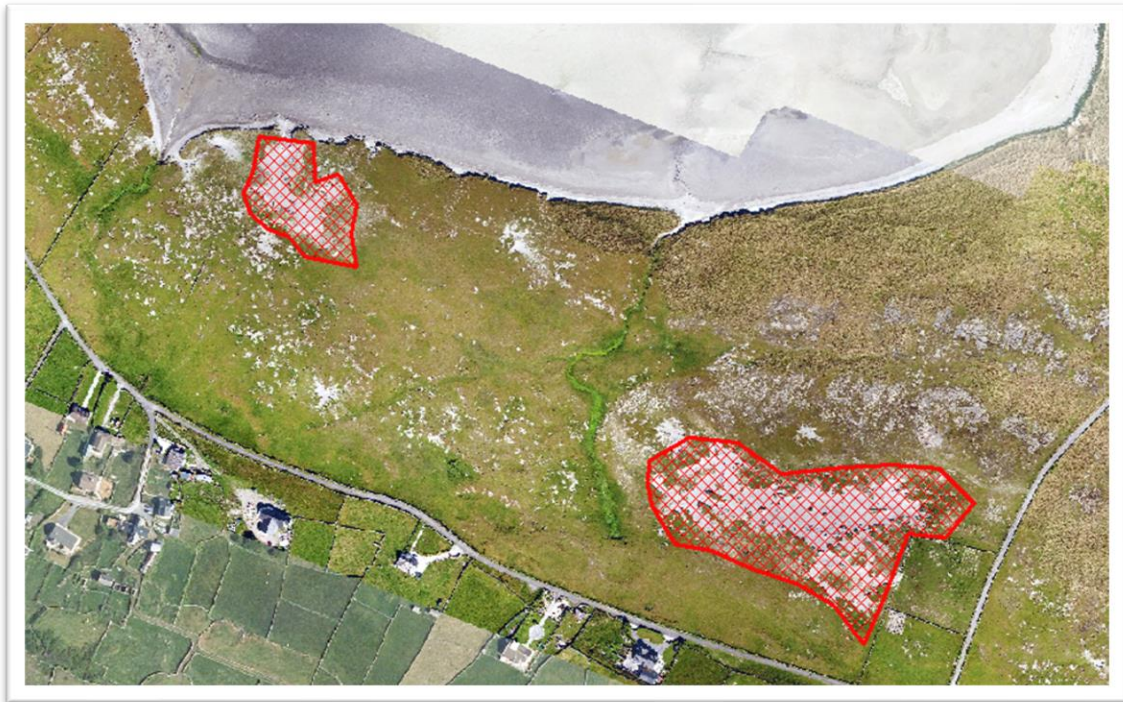
Parts of the Machair are severely eroded and were getting progressively worse over the years as the rabbit population continued to grow unchecked and to graze the site heavily, throughout the year. The western and south eastern section of the Machair had some of the most eroded Machair within the site (Fig.2). Large bare sand areas occur with small islands of vegetation up to 1m in height, which are evidence of the scale of the erosion event that has taken place (Fig.3). Elsewhere smaller bare patches are common as well as areas with the thinnest covering of vegetation (Fig. 2).

Fig.2 Severely eroded areas of Machair where over grazing and burrowing by rabbits has produced large areas of bare sand which are developing in to blow-outs

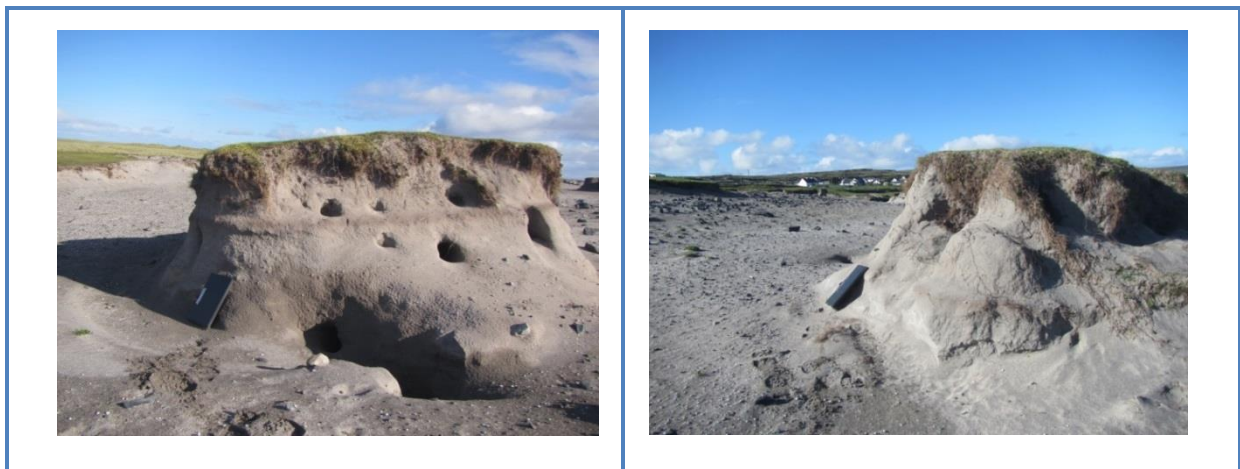
Fig.3 Steep sided Islands of vegetation remain within the eroded area, often riddled with rabbit burrows. Sides can be over 1m high, showing the volume of sand that has been lost from the site

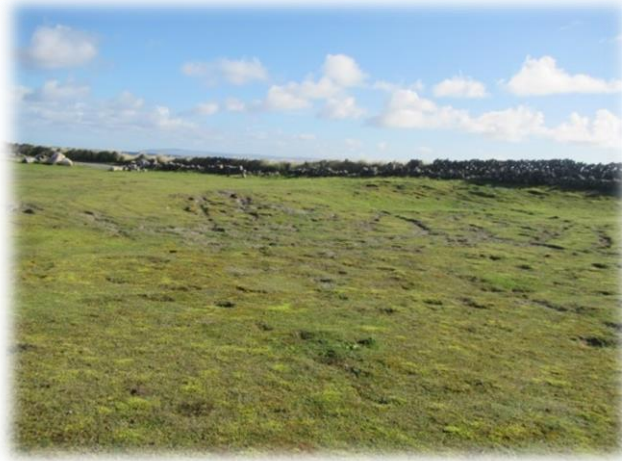
The Machair habitat has been misused in places over the years, and issues such as dumping, lighting fires and vehicle access are all having a negative impact in the more accessible parts of the Machair particularly in the western part of the Machair. These activities occur where access is easiest along the road to the beach (Figs 4, 5 & 6).

Fig.4 Tyre marks within area of western section of Machair adjacent to the road.

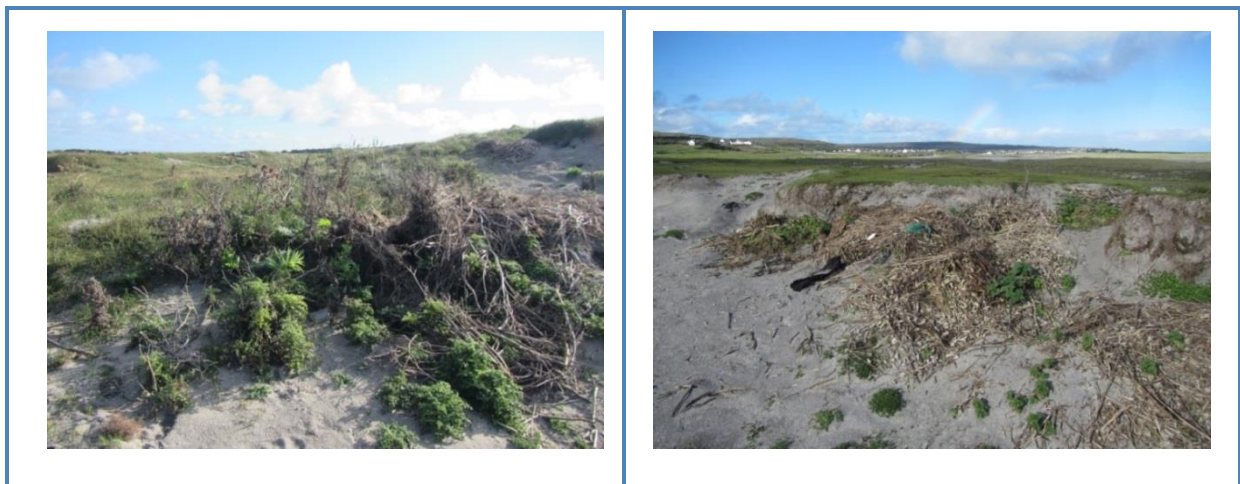
Fig.5 Dumping of garden waste on the sandy substrate leads to the development of a rank flora composed of nettles, thistles and butterbur. The dumping of hedge cuttings can also lead to the establishment of invasive species on this priority habitat.

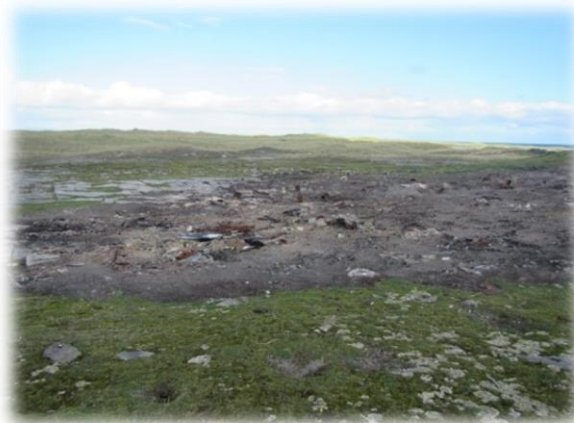
Fig.6 Large burn scar from bonfires in the western section of the Machair within easy access from road. Remains of burnt rubbish from cans, furniture and glass scatter the area.

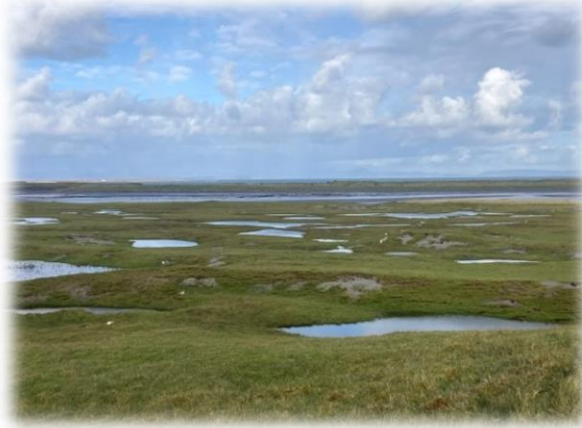
Fig.7 Flooding on the Machair during the winter

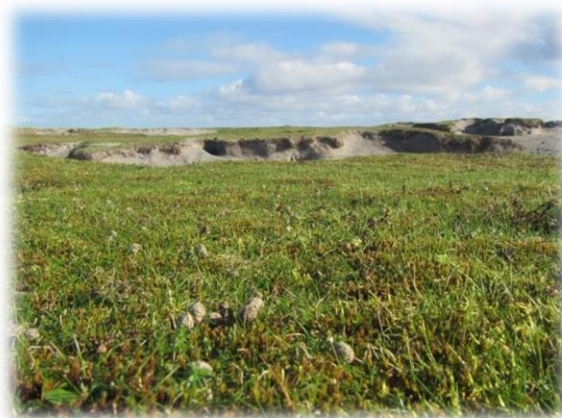
Fig.8 Vegetation cover where present, consists of a very short turf composed of bryophytes and herb, grass and sedge species

The vegetation of the Machair at Trá Mór has been detailed in previous surveys of the area during the precursor project of Caomhnú Árann, AranLIFE (¹Report on seaweed trials on Machair and ²Update to Machair Report). Throughout the Machair the vegetation, where present, is grazed heavily to a short turf that is composed primarily of bryophytes (Fig.8) along with herbaceous species such as Bulbous buttercup (*Ranunculus bulbosus*), Long-leaved plantain (*Plantago lanceolata*), Biting stone crop (*Sedum acre*), White clover (*Trifolium repens*), Daisy (*Bellis perennis*), Sand pansy (*Viola tricolor var. curtsii*) (Fig.9), Storks-bill (*Erodium cicutarium*), Birds-foot-trefoil (*Lotus corniculatus*), Lady's bedstraw (*Galium verum*), Wild thyme (*Thymus polytrichus*), Kidney vetch (*Anthyllis vulneraria*) (Fig.10) and Scarlet pimpernell (*Anagallis arvensis*) (Fig. 8 & 9). Other common species throughout include Red fescue (*Festuca rubra*) and Sand sedge (*Carex arenaria*) and Glaucous sedge (*Carex flacca*). The lichen *Peltigera canina* occurs occasionally as well as other lichen species. The heavy grazing pressure on this habitat throughout the year reduces the species diversity of the Machair habitat and causes severe erosion in parts of the Machair.

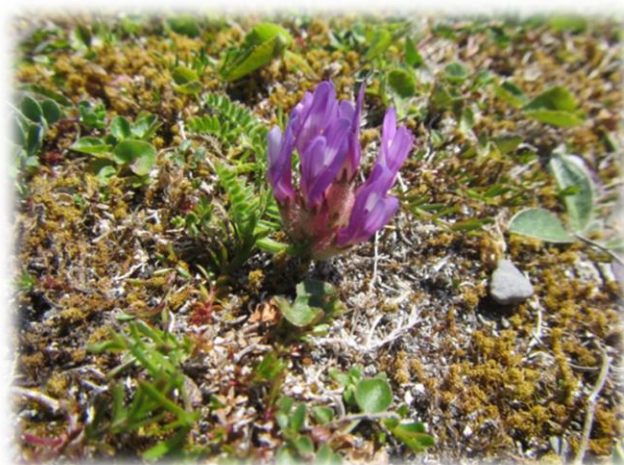
Fig.10 Purple milk vetch *Astragalus danicus*, its only stations in Ireland occur on Inis Mór and Inis Meáin. The growth of *Astragalus danicus* is much more vigorous at other stations on the islands which are not impacted by rabbit grazing.

Purple Milk-vetch (*Astragalus danicus*), (Fig. 10), grows on Machair and sandy places close to the sea. It is confined in Ireland to Inis Mór and Inis Meáin and is legally protected under the Flora (Protection) Order, 1999. The growth of this plant at this site is very much reduced compared to its growth at other sites on the islands. This reduced vigour is likely due to the grazing pressure from the rabbits.

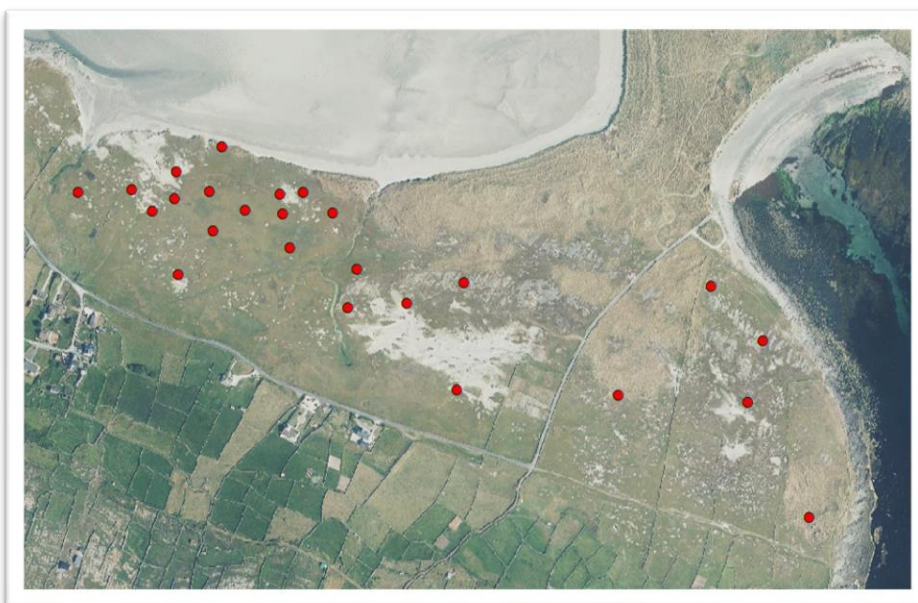
Fig.13 Survey work in April 2023, map showing 25 lapwing nest sites, overall breeding pair numbers are rising

The tightly grazed swards on the Machair, associated with damp areas, means the site is suitable habitat for Lapwing (*Vanellus vanellus*) (Fig.11.). Lapwings have undergone severe declines in breeding numbers: the most recent Bird Atlas reported a 53% decrease in its breeding range in Ireland in the last 40 years. Numbers at previous strongholds such as the Shannon Callows have declined by more than 80% in recent decades. Trá Mór has a strong lapwing population, so bird counts were taken in 2022 and 2023 to monitor the population. Figure 12 and Figure 13 details nest sites identified over the two counts and showed an increase in numbers in the second year.

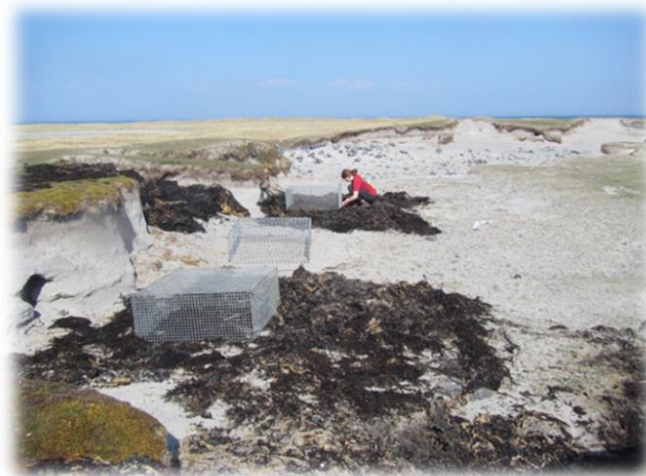
To encourage stabilisation of eroding substrate storm deposited seaweed was applied to the bare sand areas within the trial plot. The seaweed increases the water retaining capacity of the substrate and increases the organic content thereby facilitating revegetation. In some areas wild flower seed collected from a nearby Machair site on Inis Meáin was also be applied to the test plots to encourage the establishment of vegetation cover to the site. A test site was also trialled to test the effectiveness of planting plugs of Kidney Vetch (*Anthyllis vulneraria*), Birdsfoot (*Lotus corniculatus*) and Ladies Bedstraw (*Galium verum*), grown from seed collected on the island. Enclosure cages (Fig.14) were established on different areas which prevented rabbit access and allowed the vegetation recovery to be monitored (Fig.15).

Fig.14 Enclosure cages to prevent rabbit access with different treatments

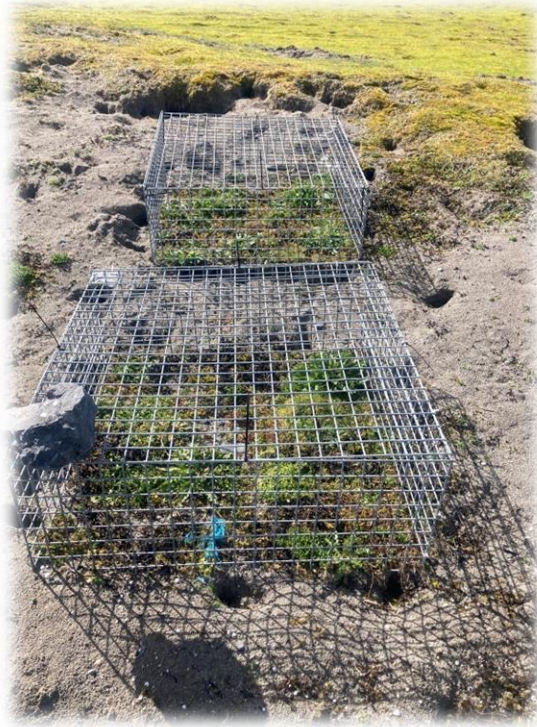
The result of this work was successful if rabbit grazing could be excluded, which good strike rates and cover from the treated areas although the planting of plugs was less successful, likely due to the sand blowing over the area increase planting depth. Electric fencing (Fig.16) was also tried as a way to exclude rabbits from the re-vegetating areas, but a trial area proved unsuccessful with rabbits continuously breaching the fence. Due to the cost of fencing on a large scale this was rejected as a suitable measure.

Fig.15 Vegetation growth within cage as a result of seed application, seaweed and rabbit exclusion.

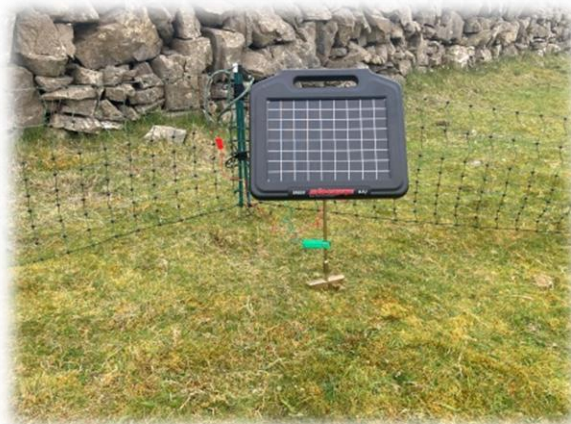
Fig.16 Proprietary rabbit control fencing was trialled but proved to be ineffective at a large scale.

- Ongoing rabbit culls are required. Rabbit electric fencing had limitations for larger scale sites.
- Other features of the site need to be considered when developing a management plan. Overgrazing is detrimental to the botanical interest of the sward but can be beneficial to other species, such as Lapwing.

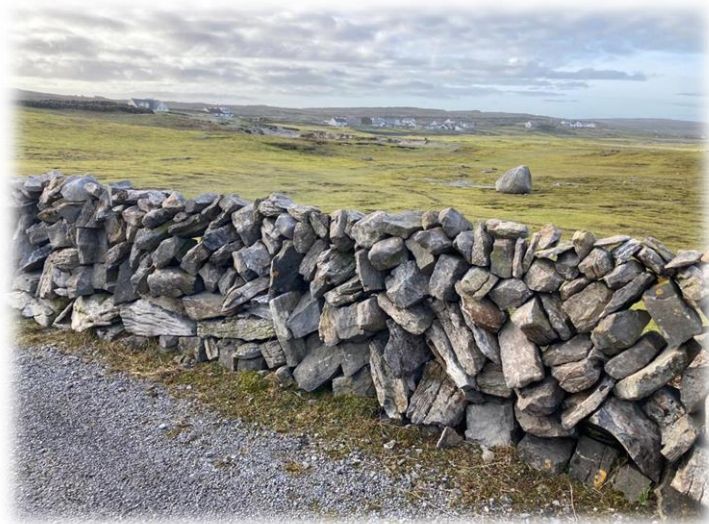
Fig.17 Part of the stone wall built on the east side of the Machair to control grazing and reduce access to vehicles.

Damaged walls on the boundary of the site were allowing vehicle access resulting in added damage. As part of the project actions these damaged walls were rebuilt using local labour and expertise (Fig.17). Stone from within the site was primarily used and with additional unquarried stone sourced nearby. Gates were installed at suitable access points to give the farmers greater control on access. This facilitates the movement and management of cattle as well as limiting misuse of the Machair habitat.

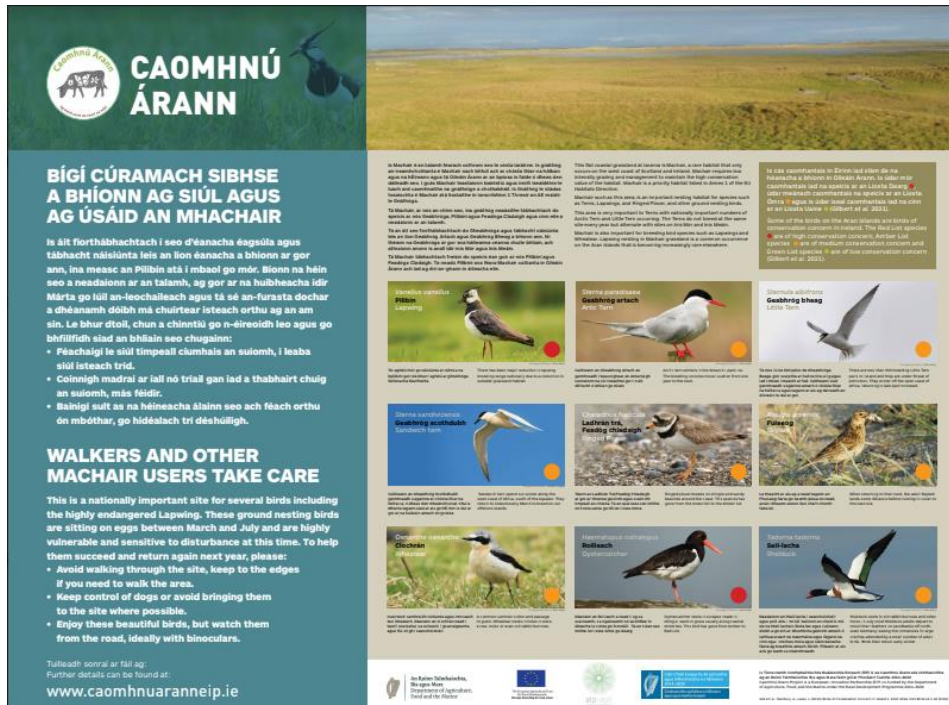
Fig.21 The information signs that are been used to raise awareness of the site and limit disturbance during the nesting season.

To aid management and inform the public, notice boards were placed around the site during the lapwing breeding site. This was initiated by the farmers as there were concerns regarding a high number of people exercising on the site with unleashed dogs. These notice boards will be maintained by the farmers and the Acres BurrenAran Co-operation team. Details of the notice boards are detailed in Figure 21. The co-operation team are looking at ways of continue to raise awareness of the importance of the site and have spoken to some of the tour guides on the island as this further raises awareness on the importance of the site.
