Report of the Pyrite Panel

June 2012

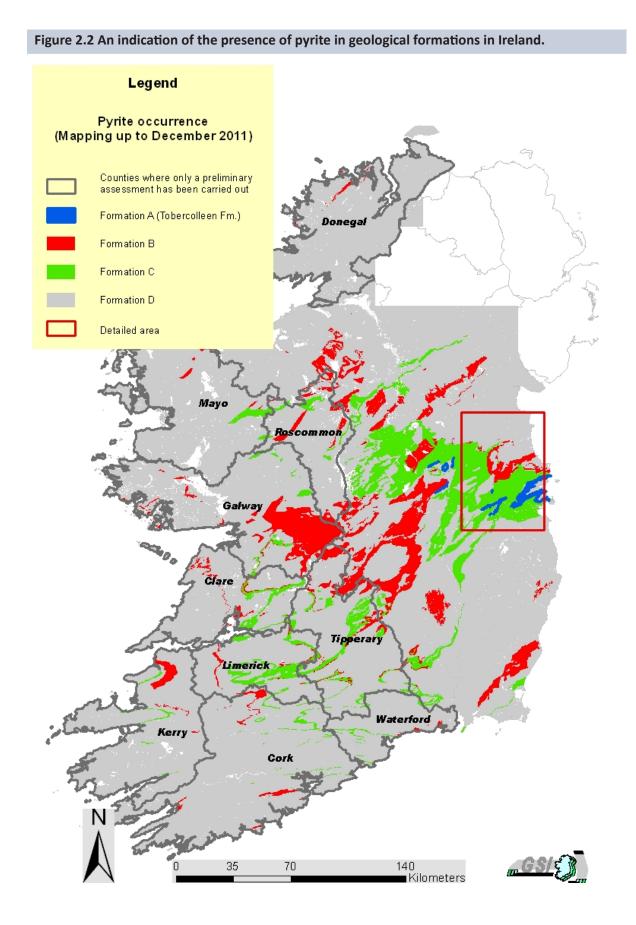
The national geological map is generated from over 24,000 polygons and each polygon has been assessed individually (except for the counties illustrated in Figure 2.2 where in these cases a generalisation has been made). It should be emphasised that this is a preliminary exercise generated by the GSI at the request of the Pyrite Panel.

The purpose of these maps is to provide a general indication of where pyrite might occur across Ireland. As a generalisation, it should not be used to draw conclusions about specific sites or locations. The suitability of any particular location or site needs to be assessed on its own merits. These maps should not be used as a basis for such assessment.

The presence of pyrite is not confined to particular geological formations (e.g Tobercolleen Formation). It is widespread and the likelihood of the presence of pyrite across the country is illustrated in Figure 2.2. A testing and inspection regime for all quarries, by suitably qualified personnel, should be established. This should identify the presence of pyrite and reduce the risk of reactive pyrite being present in hardcore used in buildings. It should also help to ensure that hardcore meets the appropriate specification.

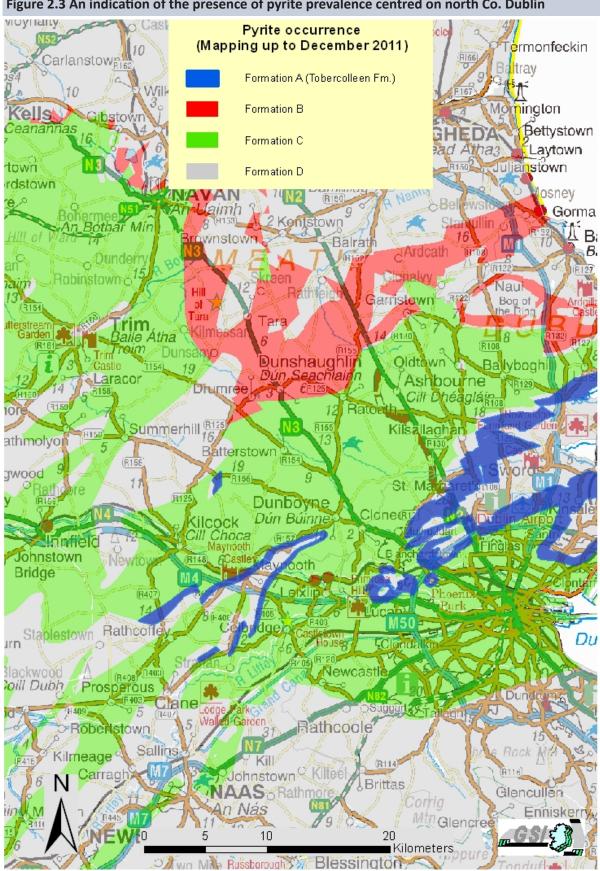
Figures 2.2 and 2.3 subdivide the many geological formations in the country into four groups labelled for simplicity as formations A (Tobercolleen Formation), B, C and D on the maps. It should be understood that this is not to imply that there are only four rock formations in the country but rather they are an attempt to provide an indication of the prevalence of pyrite across the country. The four groups are explained in the following paragraphs.

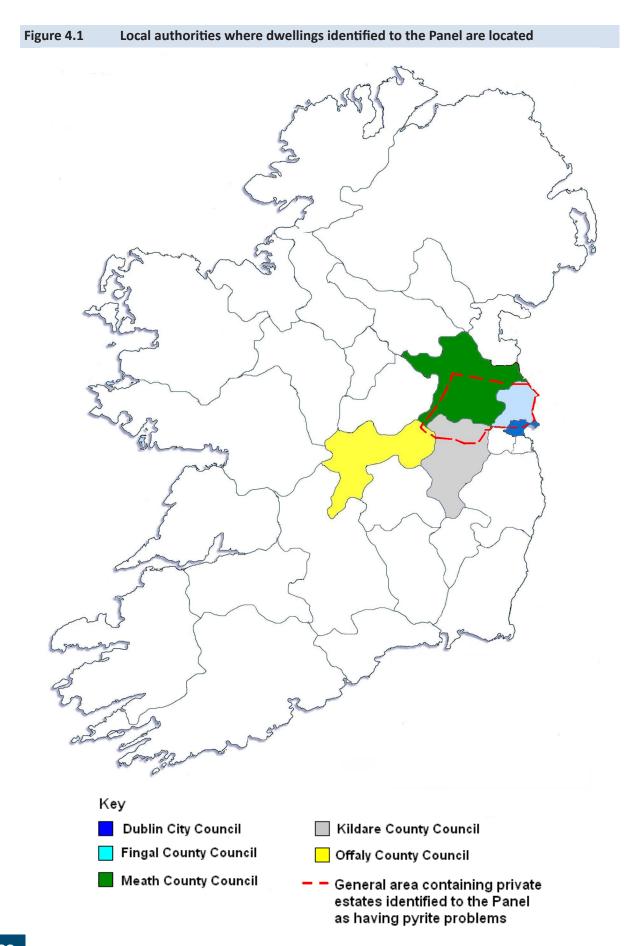
The local authority areas identified to the Panel as having problems with pyrite are Fingal County Council, Dublin City Council, Meath County Council, Kildare County Council and Offaly County Council (refer to Figure 4.1).

The boundary of the area containing all of the private housing estates identified to the Panel during the course of its study is broadly defined by a broken red line in Figure 4.1. Whilst Fingal County Council and Meath County Council contain the majority of identified estates, the problem does not appear to be as extensive throughout the remaining local authorities of Dublin City, Kildare, and Offaly. Indeed, in County Offaly identified estates appear to be localised in an urban area on the Offaly/ Kildare border.

Five (5) quarries were identified to the Panel as possible source of hardcore used in dwellings displaying signs of pyritic heave. These quarries are all located inside the boundary defined by a broken red line in Figure 4.1. For further information on the geology of this area, refer to section 2.2 of Chapter 2. Due to legal, commercial and other sensitivities that surround the pyrite issue, the names and exact locations of suspected quarries identified to the Panel are not included. As a general rule of thumb, in order to make transport costs for hardcore fill commercially viable, the haulage distances from source are generally limited to a range of between 15 and 20km, with a maximum limit generally of 25km from the source.

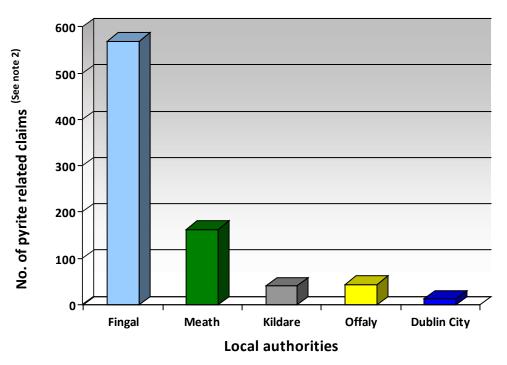
Figure 4.2 shows the distribution of pyrite-related claims made to the main guarantee providers for each local authority. It is observed that the majority of pyrite-related claims relate to dwellings located in Fingal County Council, followed by Meath County Council.

- 1. The total number of pyrite-related claims (verified and un-verified) made to the main guarantee providers up to March 2012 was approximately 850.
- 2. The total number of pyrite-related claims (verified and un-verified) plus formal pyriterelated complaints made to the main guarantee provider, up to March 2012 was approximately 1050.

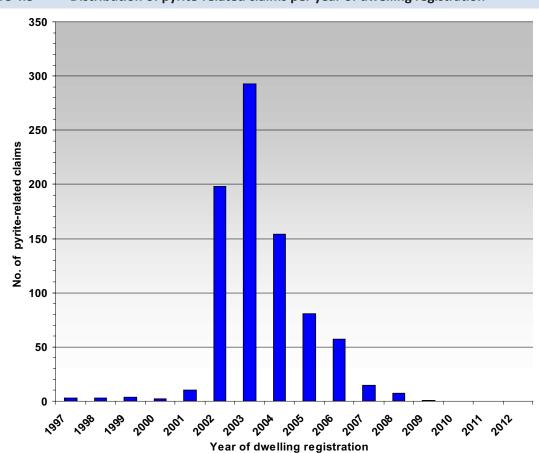
Figure 4.3 Distribution of pyrite-related claims per year of dwelling registration

When the pyrite-related claims received per year are plotted against the year of dwelling registration across all identified local authorities, a pattern emerges which suggests that dwellings registered between 2002 and 2006 contain the vast majority of all suspected cases (refer Figure 4.3).

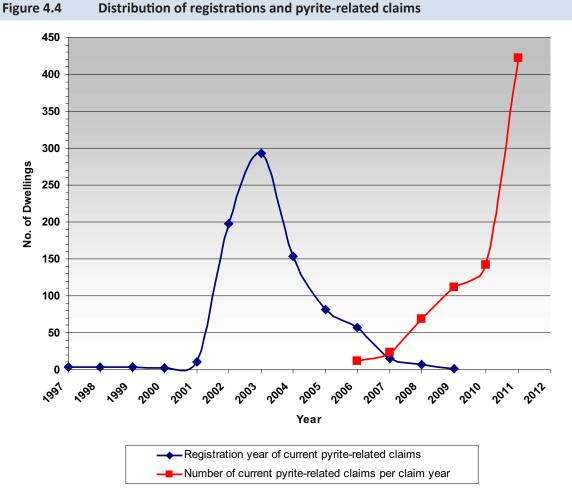
The number of pyrite-related claims made to the main guarantee providers has steadily increased from 2006 to 2010. During 2011, pyrite-related claims increased exponentially (refer to Figure 4.4). It may be expected that claims will further increase in the near future due to increased public awareness through media, legal actions and the publication of this report.

Figure 4.4 below illustrates the relationship between the year the dwelling was registered and the year when the problem became of such significance for the homeowner that they considered it necessary to take action and make a claim to one of the main guarantee providers.

- 1. The main guarantee providers advised the Panel that they were not aware that problems were pyriterelated prior to January 2007
- 2. In Fingal, seven (7) dwellings had registrations in 2008 and a single dwelling in 2009. It was confirmed to the Panel that none of these dwellings was commenced post-2007.

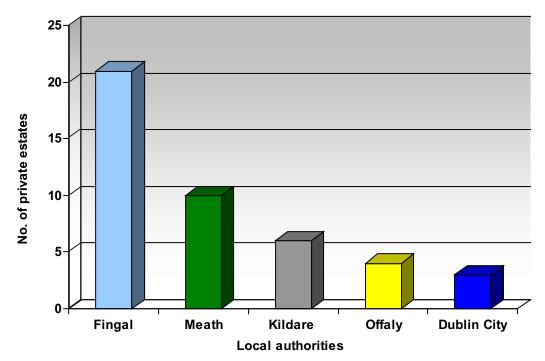
A total of forty four (44) estates were identified to the Panel as having at least one pyriterelated claim made to either one of the main guarantee providers. This figure excludes estates where remediation has already taken place. Their distribution between each local authority is shown in Figure 4.5.

- 1. 44No. private estates were identified to the Panel that have a pyrite-related claim made to a main guarantee provider and the claim has not yet been remediated.
- 2. Five (5) of these 44 estates have been partially remediated.

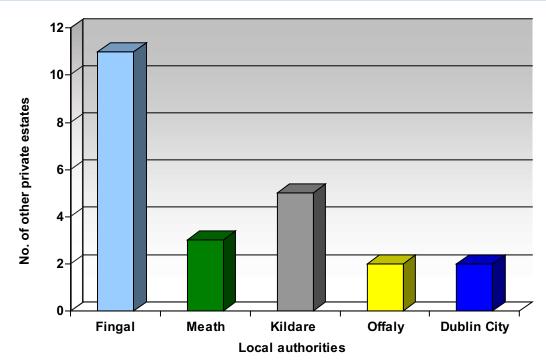
Figure 4.6 Distribution of other private estates identified to the Panel

A further twenty three (23) private estates were identified to the Panel as possibly having pyritic material present in some of the dwellings, but they do not appear to have any history of claims or remediation. These estates have been identified by some of the sources discussed in section 4.2.1. Many of them may still be covered by a guarantee provider. However, some of these estates come from older housing stock where it is likely that the guarantee has expired. The distribution of these estates is shown in Figure 4.6 over.

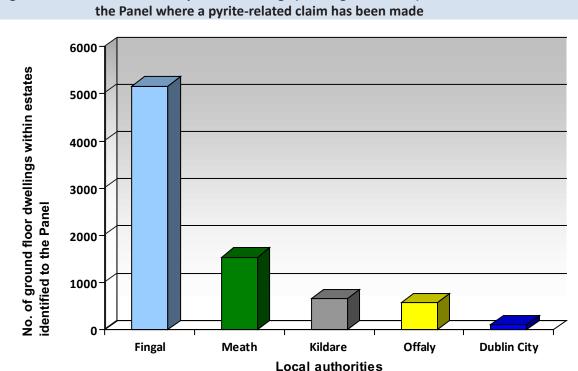
Figure 4.7 Distribution of private dwellings (with a ground floor) from estates identified to

For the estates where at least one pyrite-related claim has been made and that claim has not yet been remediated, the Panel estimates (based on the assumptions discussed in section 4.2.1) that the total potential number of private dwellings (with a ground floor) that may be exposed to the pyrite problem in the future is approximately **8,000** dwellings across 44 estates. This figure is the summation of all ground floor dwellings from estates where a pyrite-related claim has been made and which have been identified to the Panel. Figure 4.7 shows the distribution of these dwellings between each local authority.

- 1. The values above are the summation of all ground floor dwellings in 44 No. private estates identified to the Panel where at least one pyrite-related claim has been made.
- 2. The total number of private dwellings with a ground floor in these estates is approximately 8,000.

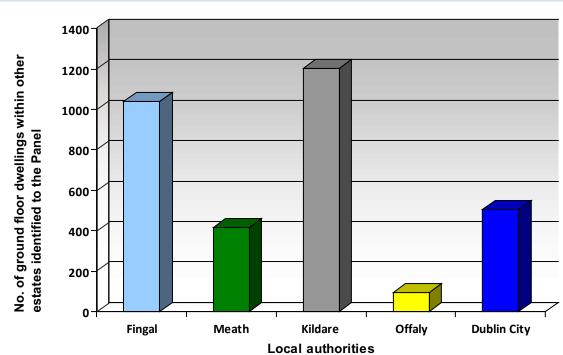
Figure 4.8 Distribution of private dwellings (with a ground floor) from other estates identified to the Panel

For the other 23 estates identified, the Panel estimates (based on the assumptions discussed in section 4.2.1) that, as a reasonably informed view, the total potential number of private dwellings (with a ground floor) that may be exposed to the pyrite problem in the future is approximately **3,250** dwellings across the 23 estates. Figure 4.8 shows the distribution of these dwellings between each local authority.

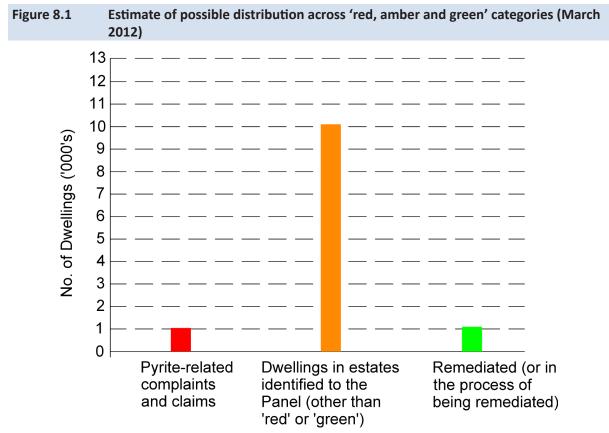
As a result of having no common protocol to date, there are no definite figures of the number of dwellings that may fall into each categorisation in developments which have confirmed or suspected pyrite problems. However, in the interest of giving indicative figures, the Panel used the data they collected (see Chapter 4 for full details of data collected) to estimate the possible distribution across red, amber and green categories. Figure 8.1 below represents the Panel's estimate of the possible distribution across the red, amber and green categories, given the information available to the Panel as of March 2012.

- 1. 'Red' includes all claims and complaints recorded by HomeBond or Premier but it should be noted that not all of the claims/complaints have been confirmed as having pyritic heave.
- 2. Not all homeowners that have experienced pyritic heave in their dwelling may have made complaints or claims but this is unquantifiable
- 3. 'Amber' represents the remaining dwellings on estates identified to the Panel. Note that the identification of pyrite in an estate does not necessarily mean that all dwellings in the estate are affected.
